### AIRCRAFT ACCIDENT INVESTIGATION

E-8C, T/N 93-0597

AL UDEID AIR BASE, QATAR

13 MARCH 2009

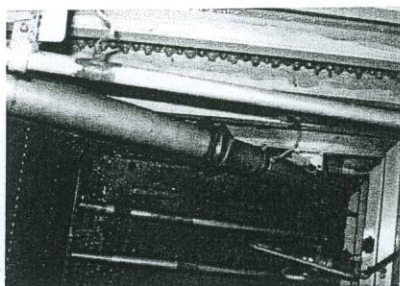
In order to borescope the tubing associated with the inboard vent (i.e. climb vent) to check for obstructions, the vent "horn" was disconnected from the tubing at the nearest joint. When the joint was disassembled, a mechanical test plug was observed installed in the outboard section of tubing. Subsequent research determined that it was an expandable test plug used to retain pressure in the tank during pressure tests. It was marked with a tool control number (8252) that was traced to Northrop Grumman's Lake Charles LCMMF PDM facility. After the plug was removed, the previous test was redone. This time, no significant change in airflow was detected with the dive vent flapper in the closed position (Tab J-31).

**Climb vent Installed**

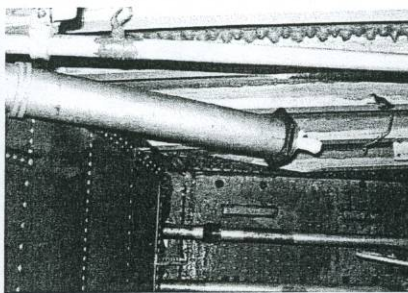
**Climb vent Removed**

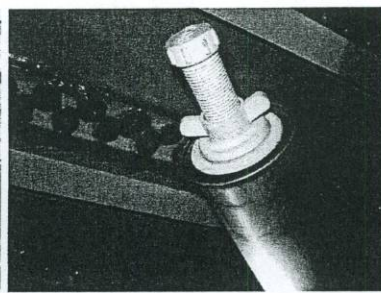
A mechanical test plug was found in the CV system of the number two tank. Contract requirements and maintenance technical manuals specifically require this mechanical test plug to have streamers attached and documentation entered in work control documents. Specifically T.O. 1-1-3, Section 2.7.6.4 requires "Remove Before Refuel/Defuel" streamers to be attached to equipment such as test plugs that could affect venting, fueling, defueling or transferring of fuel (Tab T-21). This requirement is mirrored in Tab H, Section 9.6, of the WR-ALC Technical Requirements Documents (Tab W-18). A properly installed streamer is designed to alert

mechanics that the plug is installed and shall be removed before refuel/defuel. The mechanical test plug found in the CV did not have a streamer.

**C.O.B. Plug**

The mishap was caused by the mechanical test plug erroneously left in place inside the number two main fuel tank climb vent during PDM at LCMMF that allowed air pressure to build to a point where the tank ruptured and failed during AR. There is no warning system within the fleet's fuel tanks to let the crew know this hazardous condition existed so the MC had no way of knowing the tank was about to fail before it did. The MC followed proper techniques and procedures during the AR.
